*California Department of Transportation
Division of Maintenance*

Structure Maintenance and Investigations

Bridge Number : 10 0136
Facility Carried: STATE ROUTE 1
Location : 01-MEN-001-43.74
City :
Inspection Date : 10/06/2015

STRUCTURE NAME: ALBION RIVER

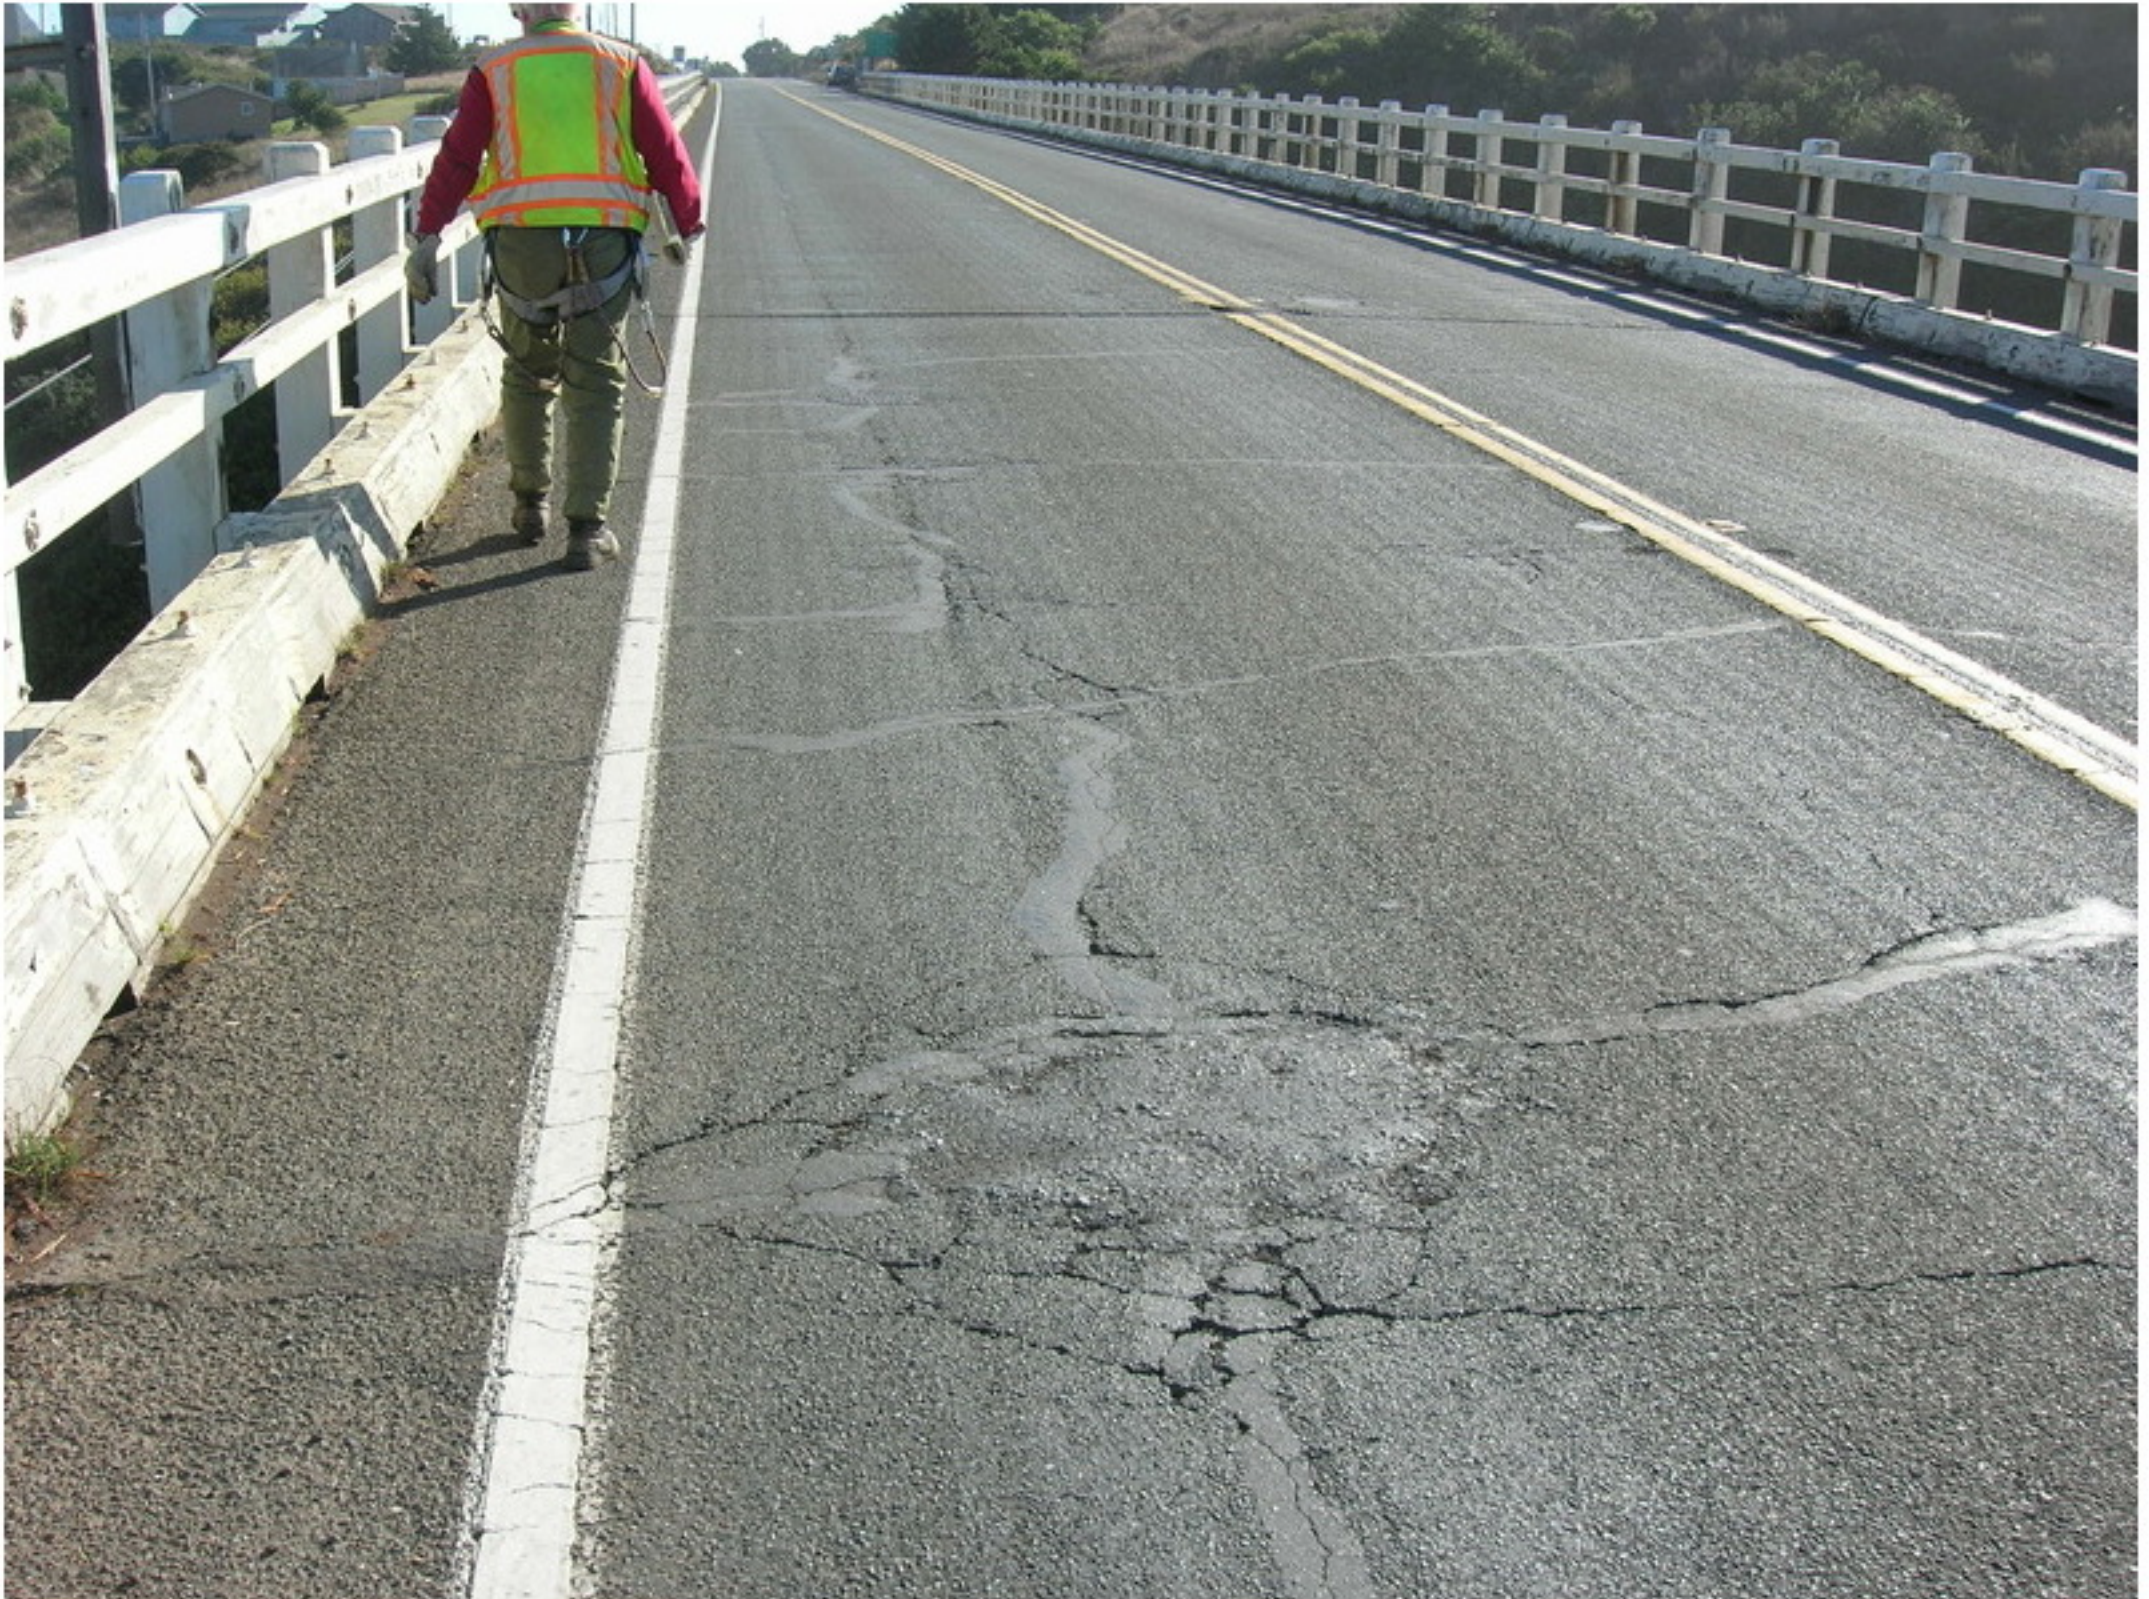
Photo No. 11

Repaired pothole in the AC in the northbound lane of one of the northern approach spans

There are numerous repaired, patched, and cracked and raveled areas in both lanes in nearly all spans. The cracking, raveling, and potholing of the AC indicates that the timber two-layer plank deck under the AC is rotting and crushing, causing the failure of the AC riding surface. The timber plank deck appears to have reached the end of its service life. Remove the AC; remove and replace any deteriorated timber planks; place a new waterproof membrane on the timber planks; place a new course of AC on the membrane.

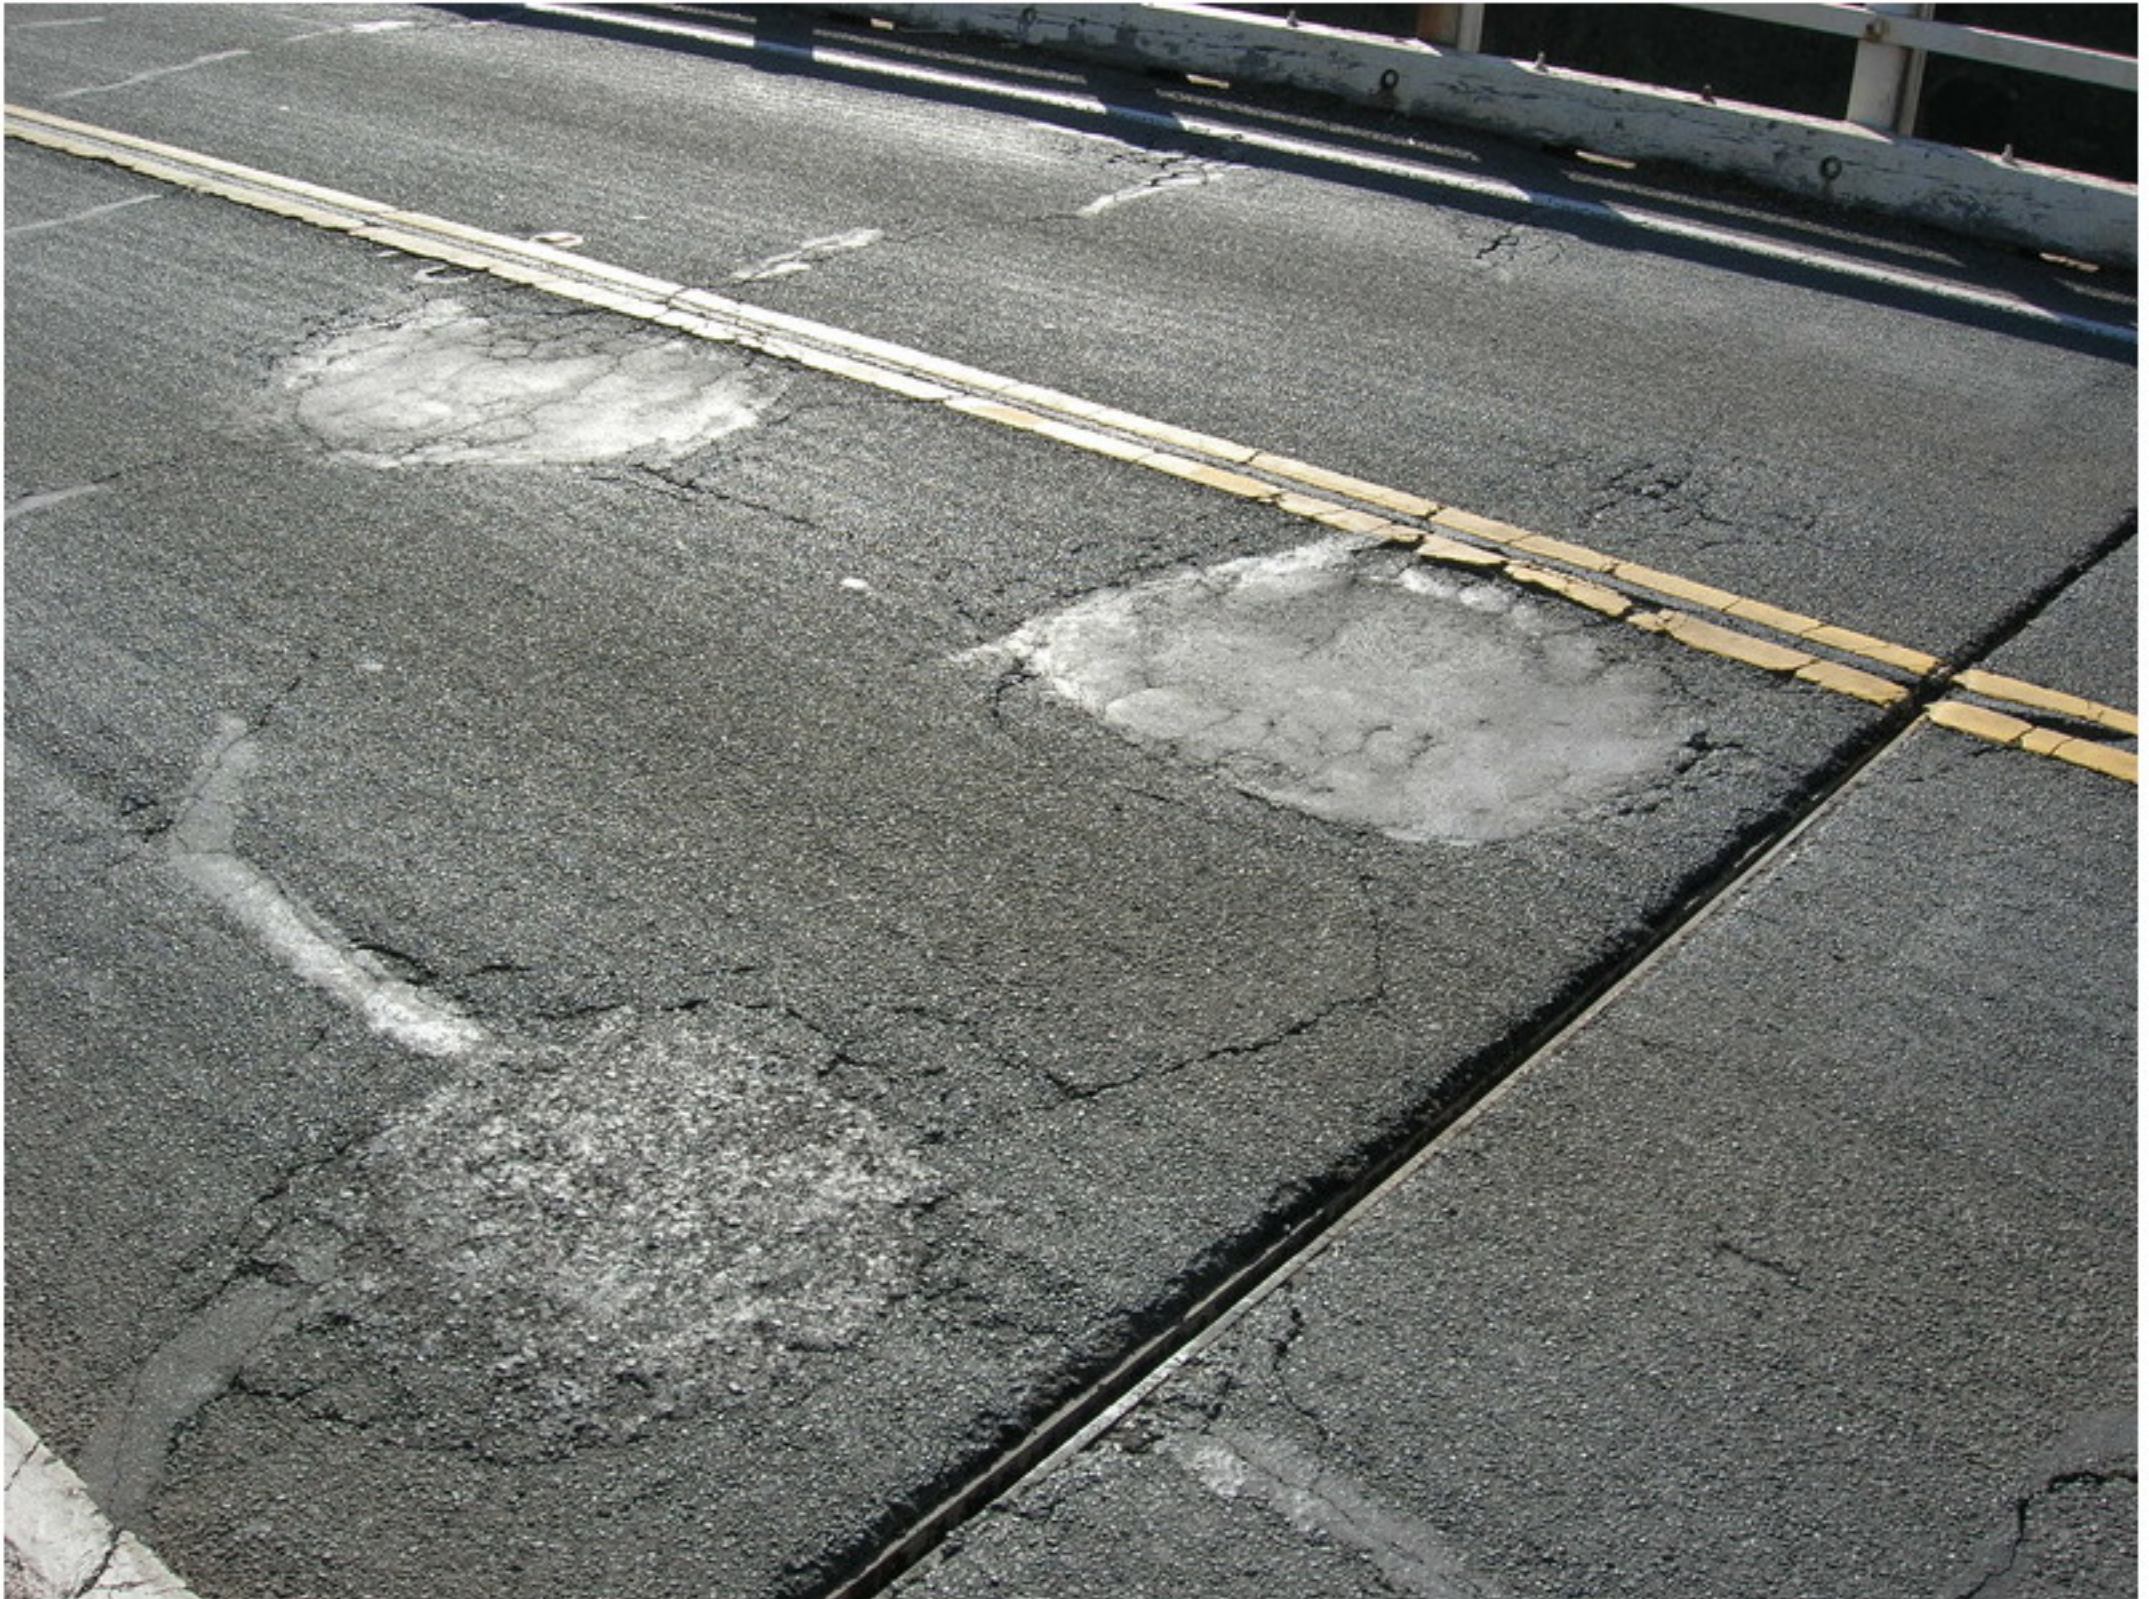
Photo No. 12

Repaired potholes & raveled AC in northbound lane at expansion joint over Bent 12

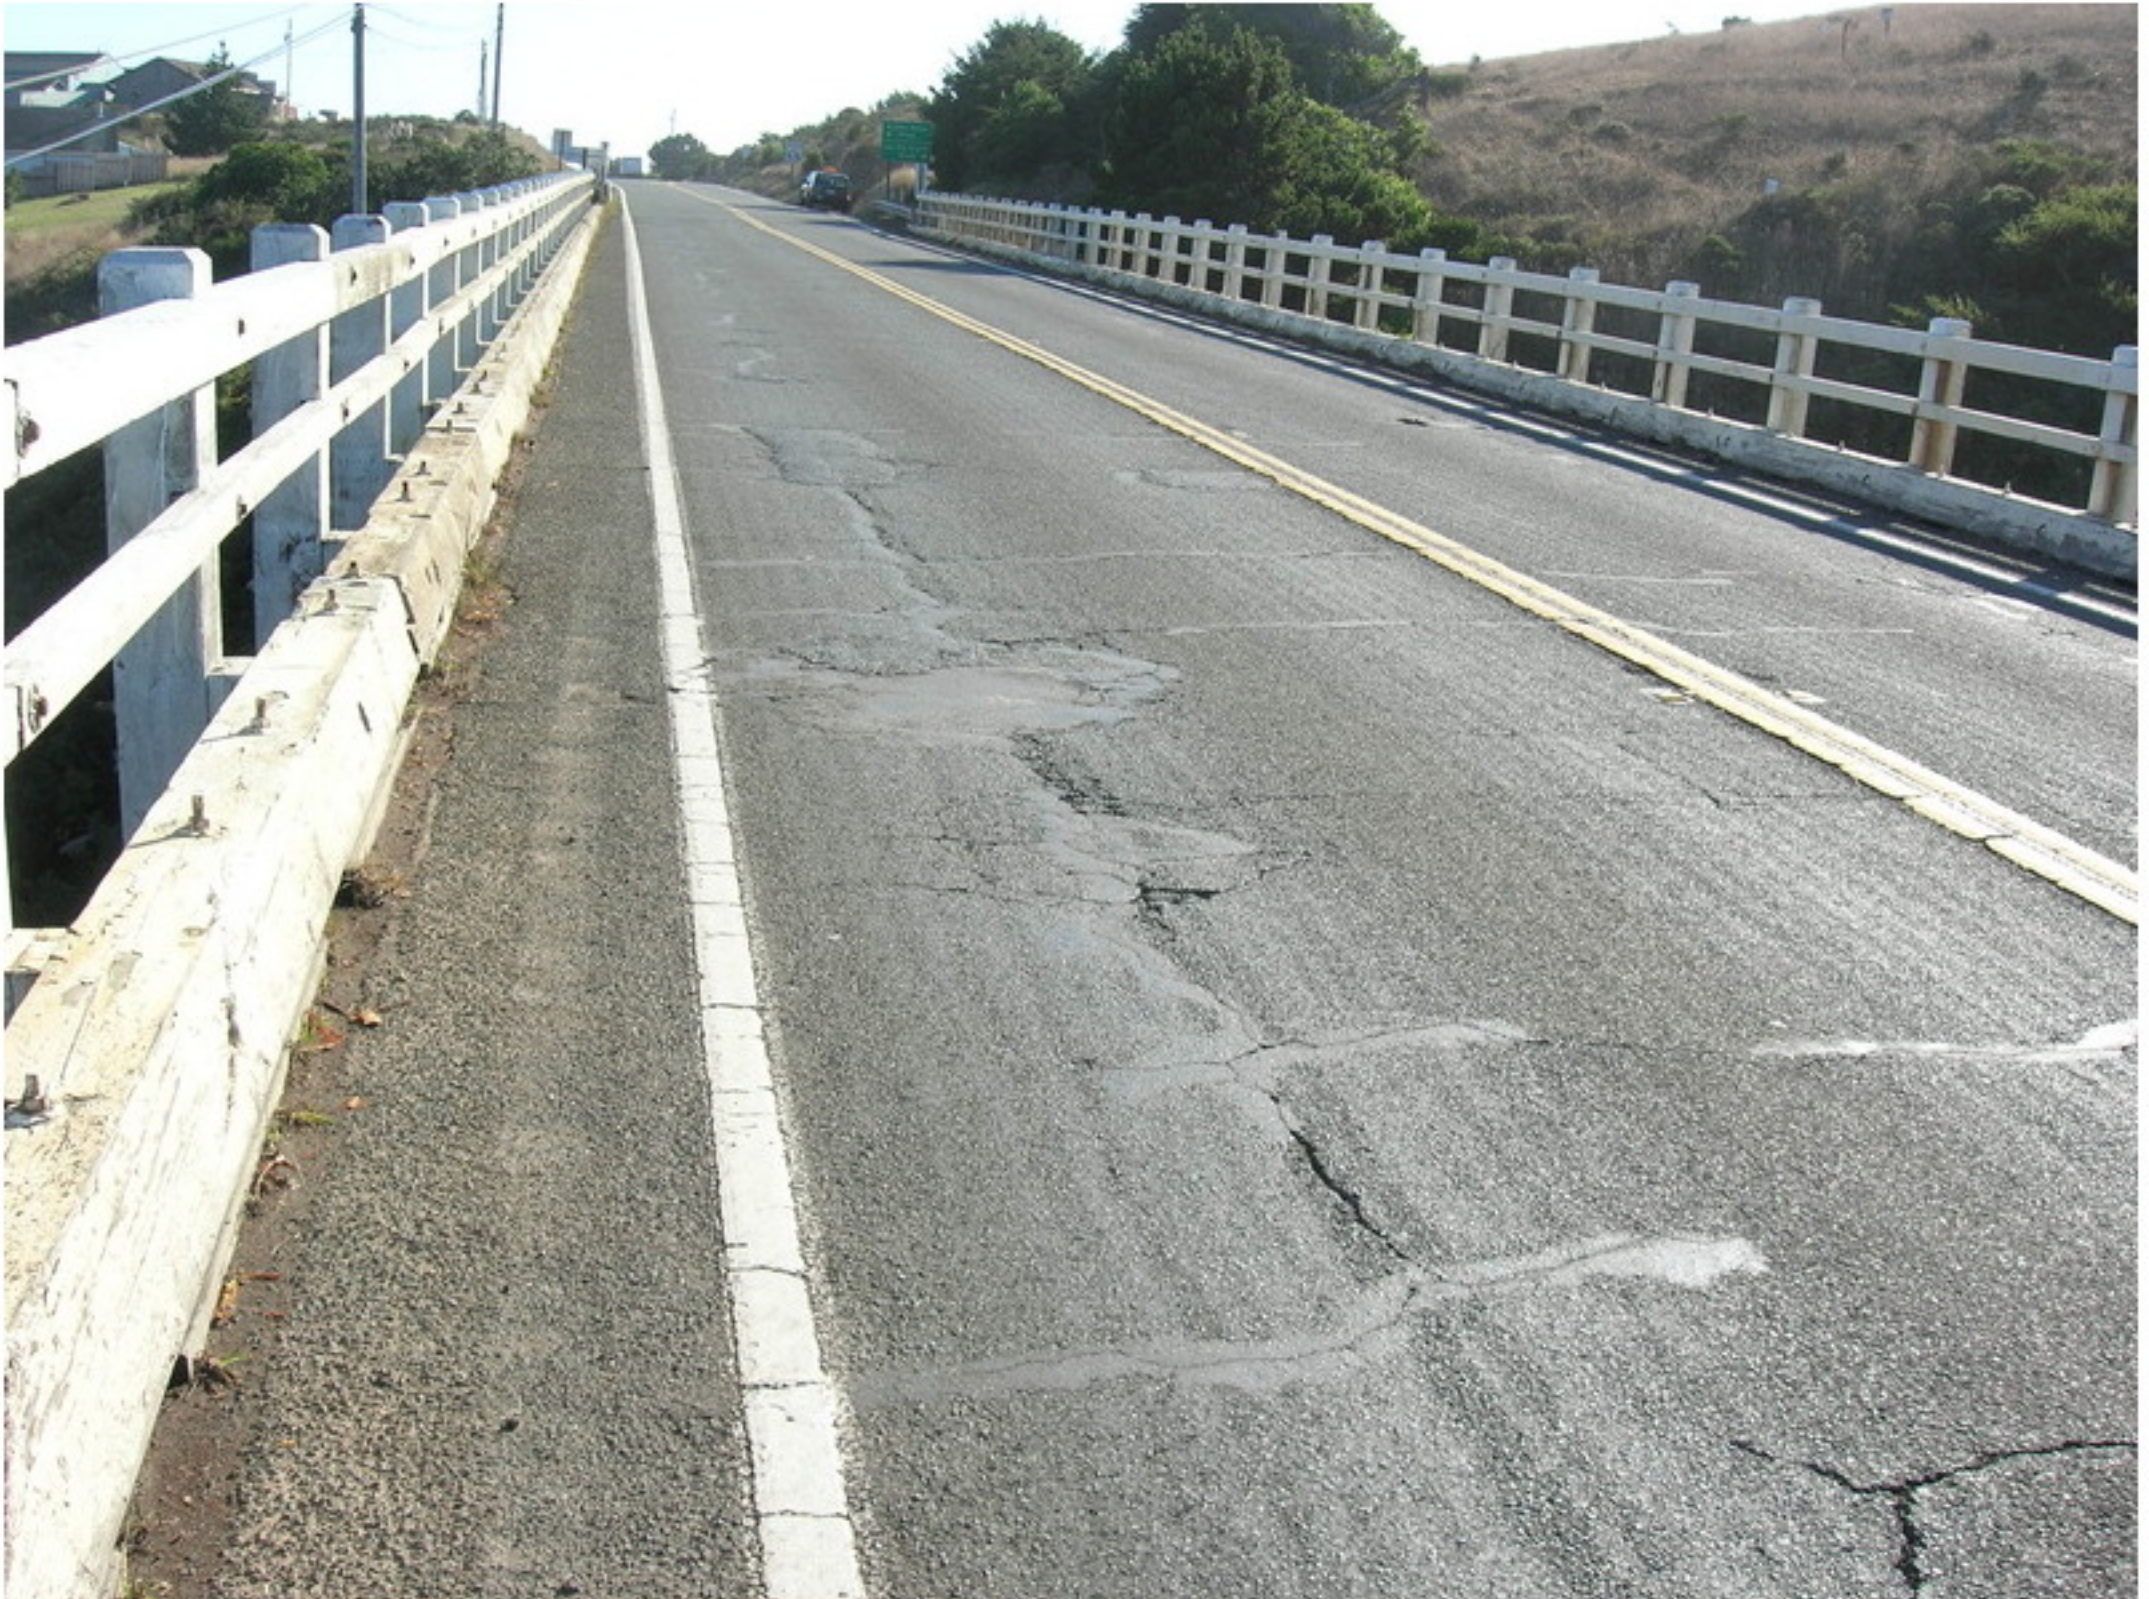
Photo No. 13
Cracks & repaired potholes in the AC in the northbound lane of the southern approach spans

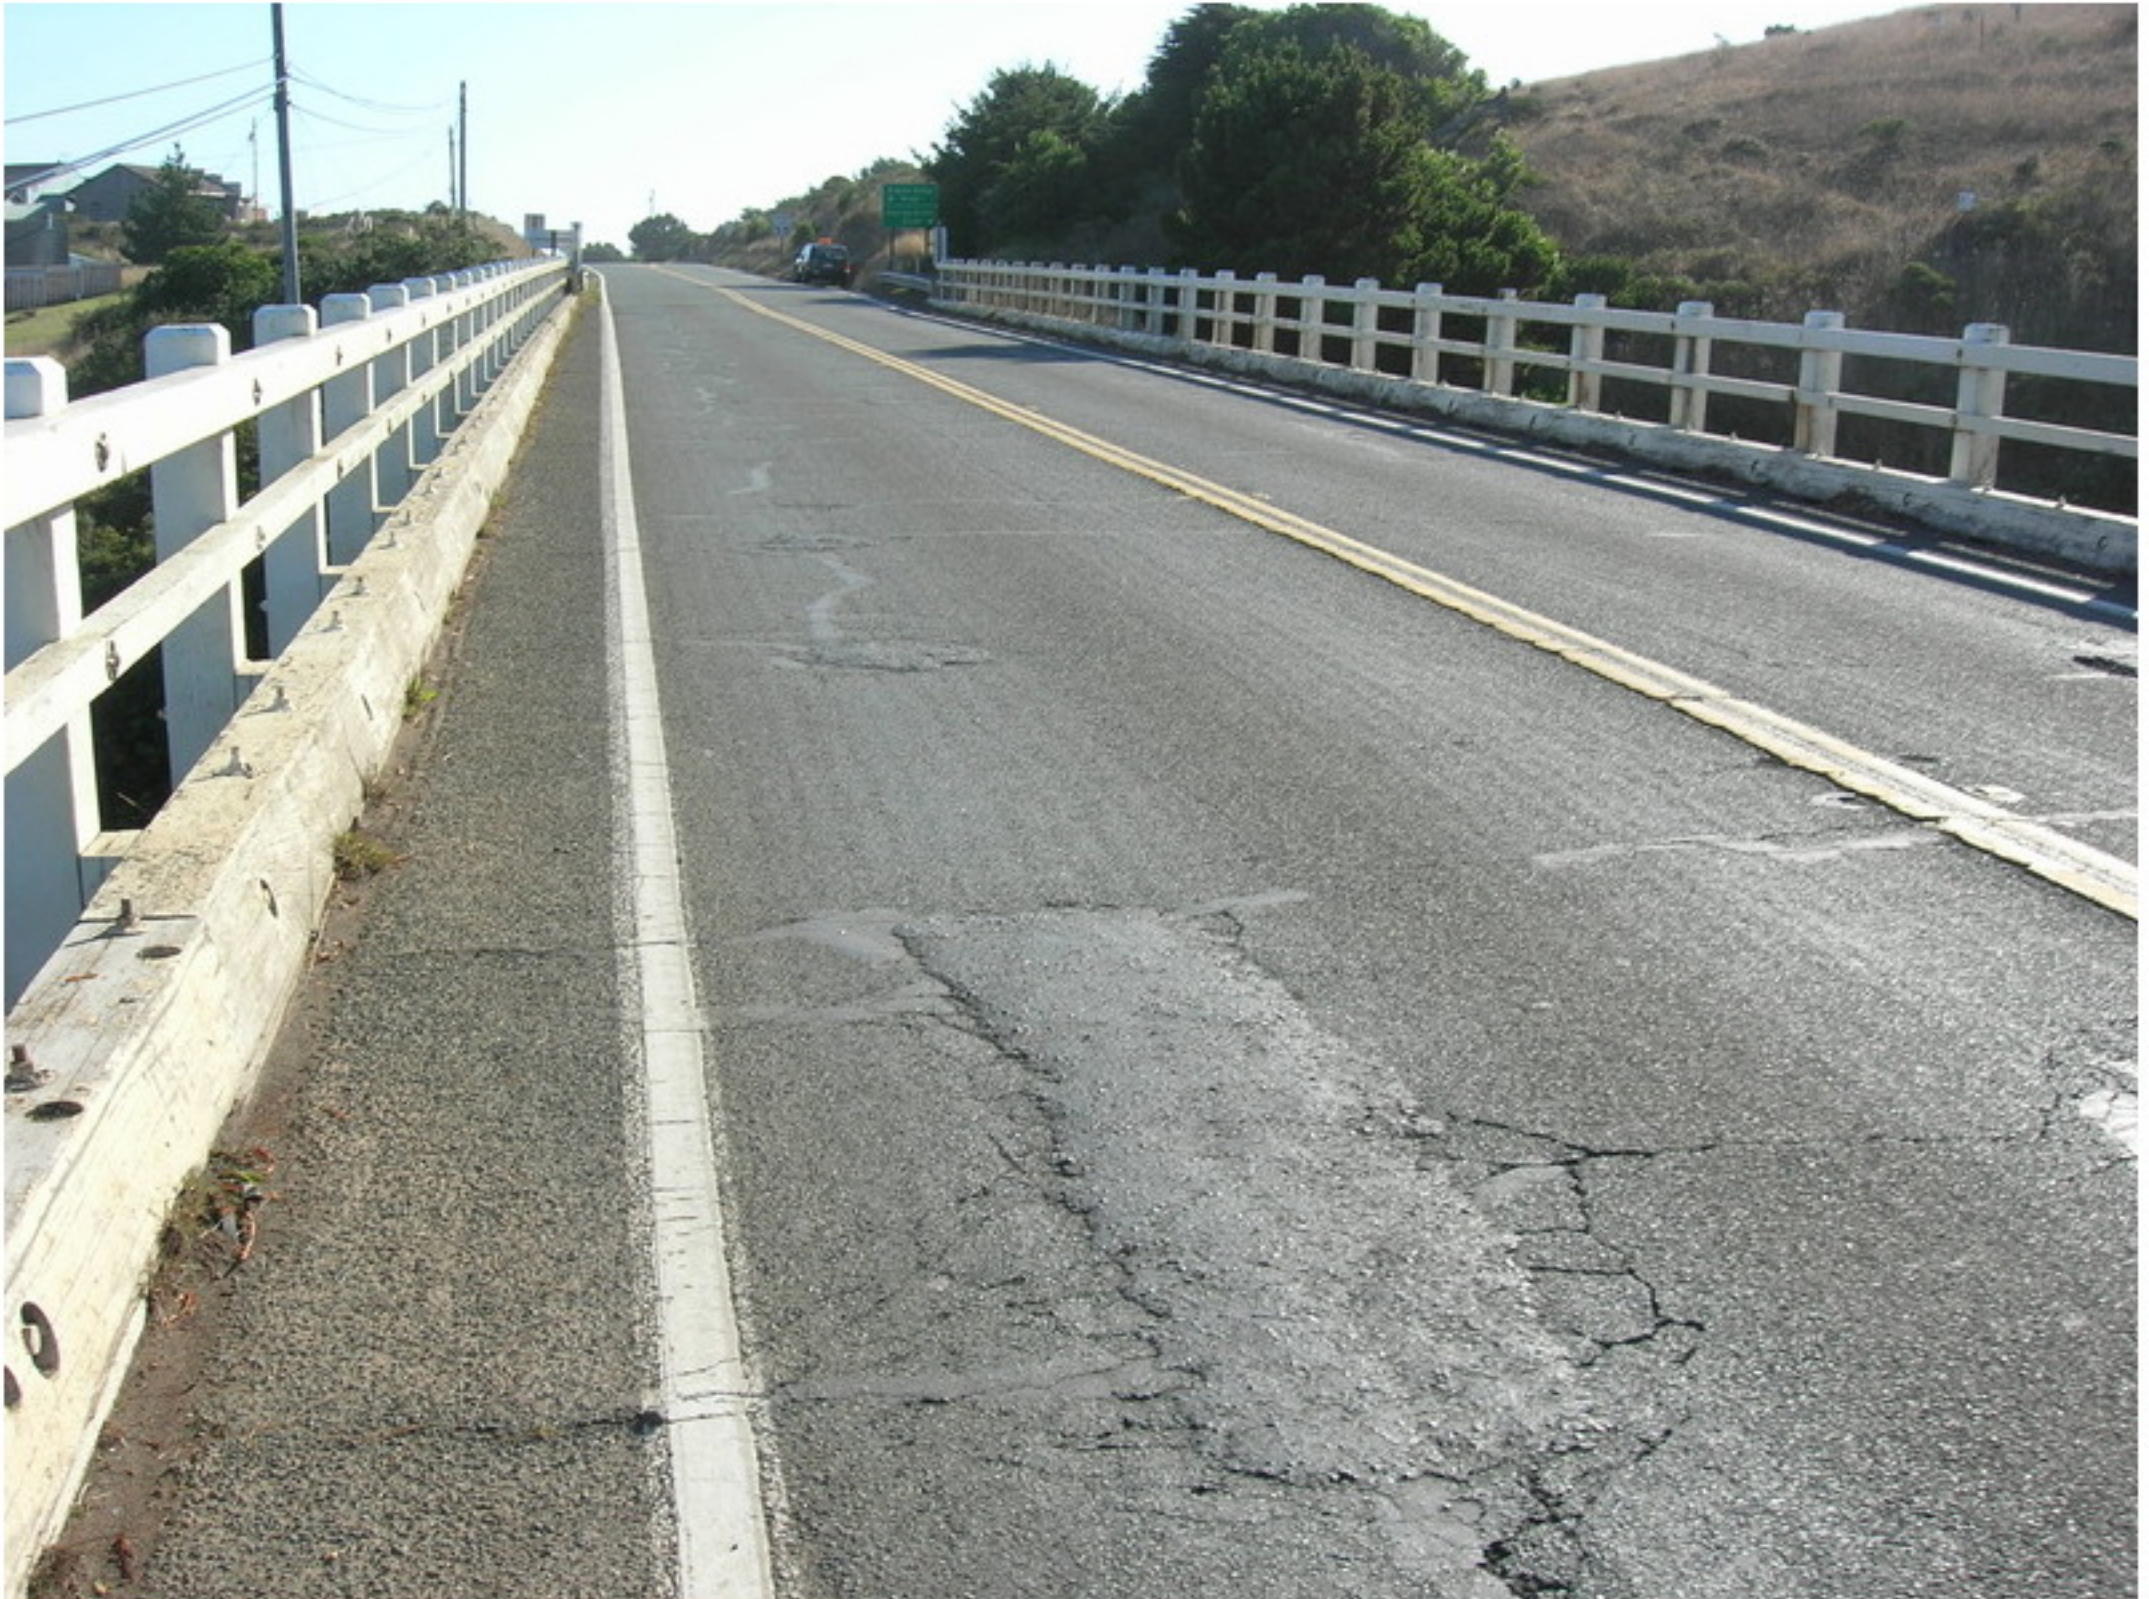
Photo No. 14
Repaired pothole in the AC in the northbound lane of one of the southern approach spans

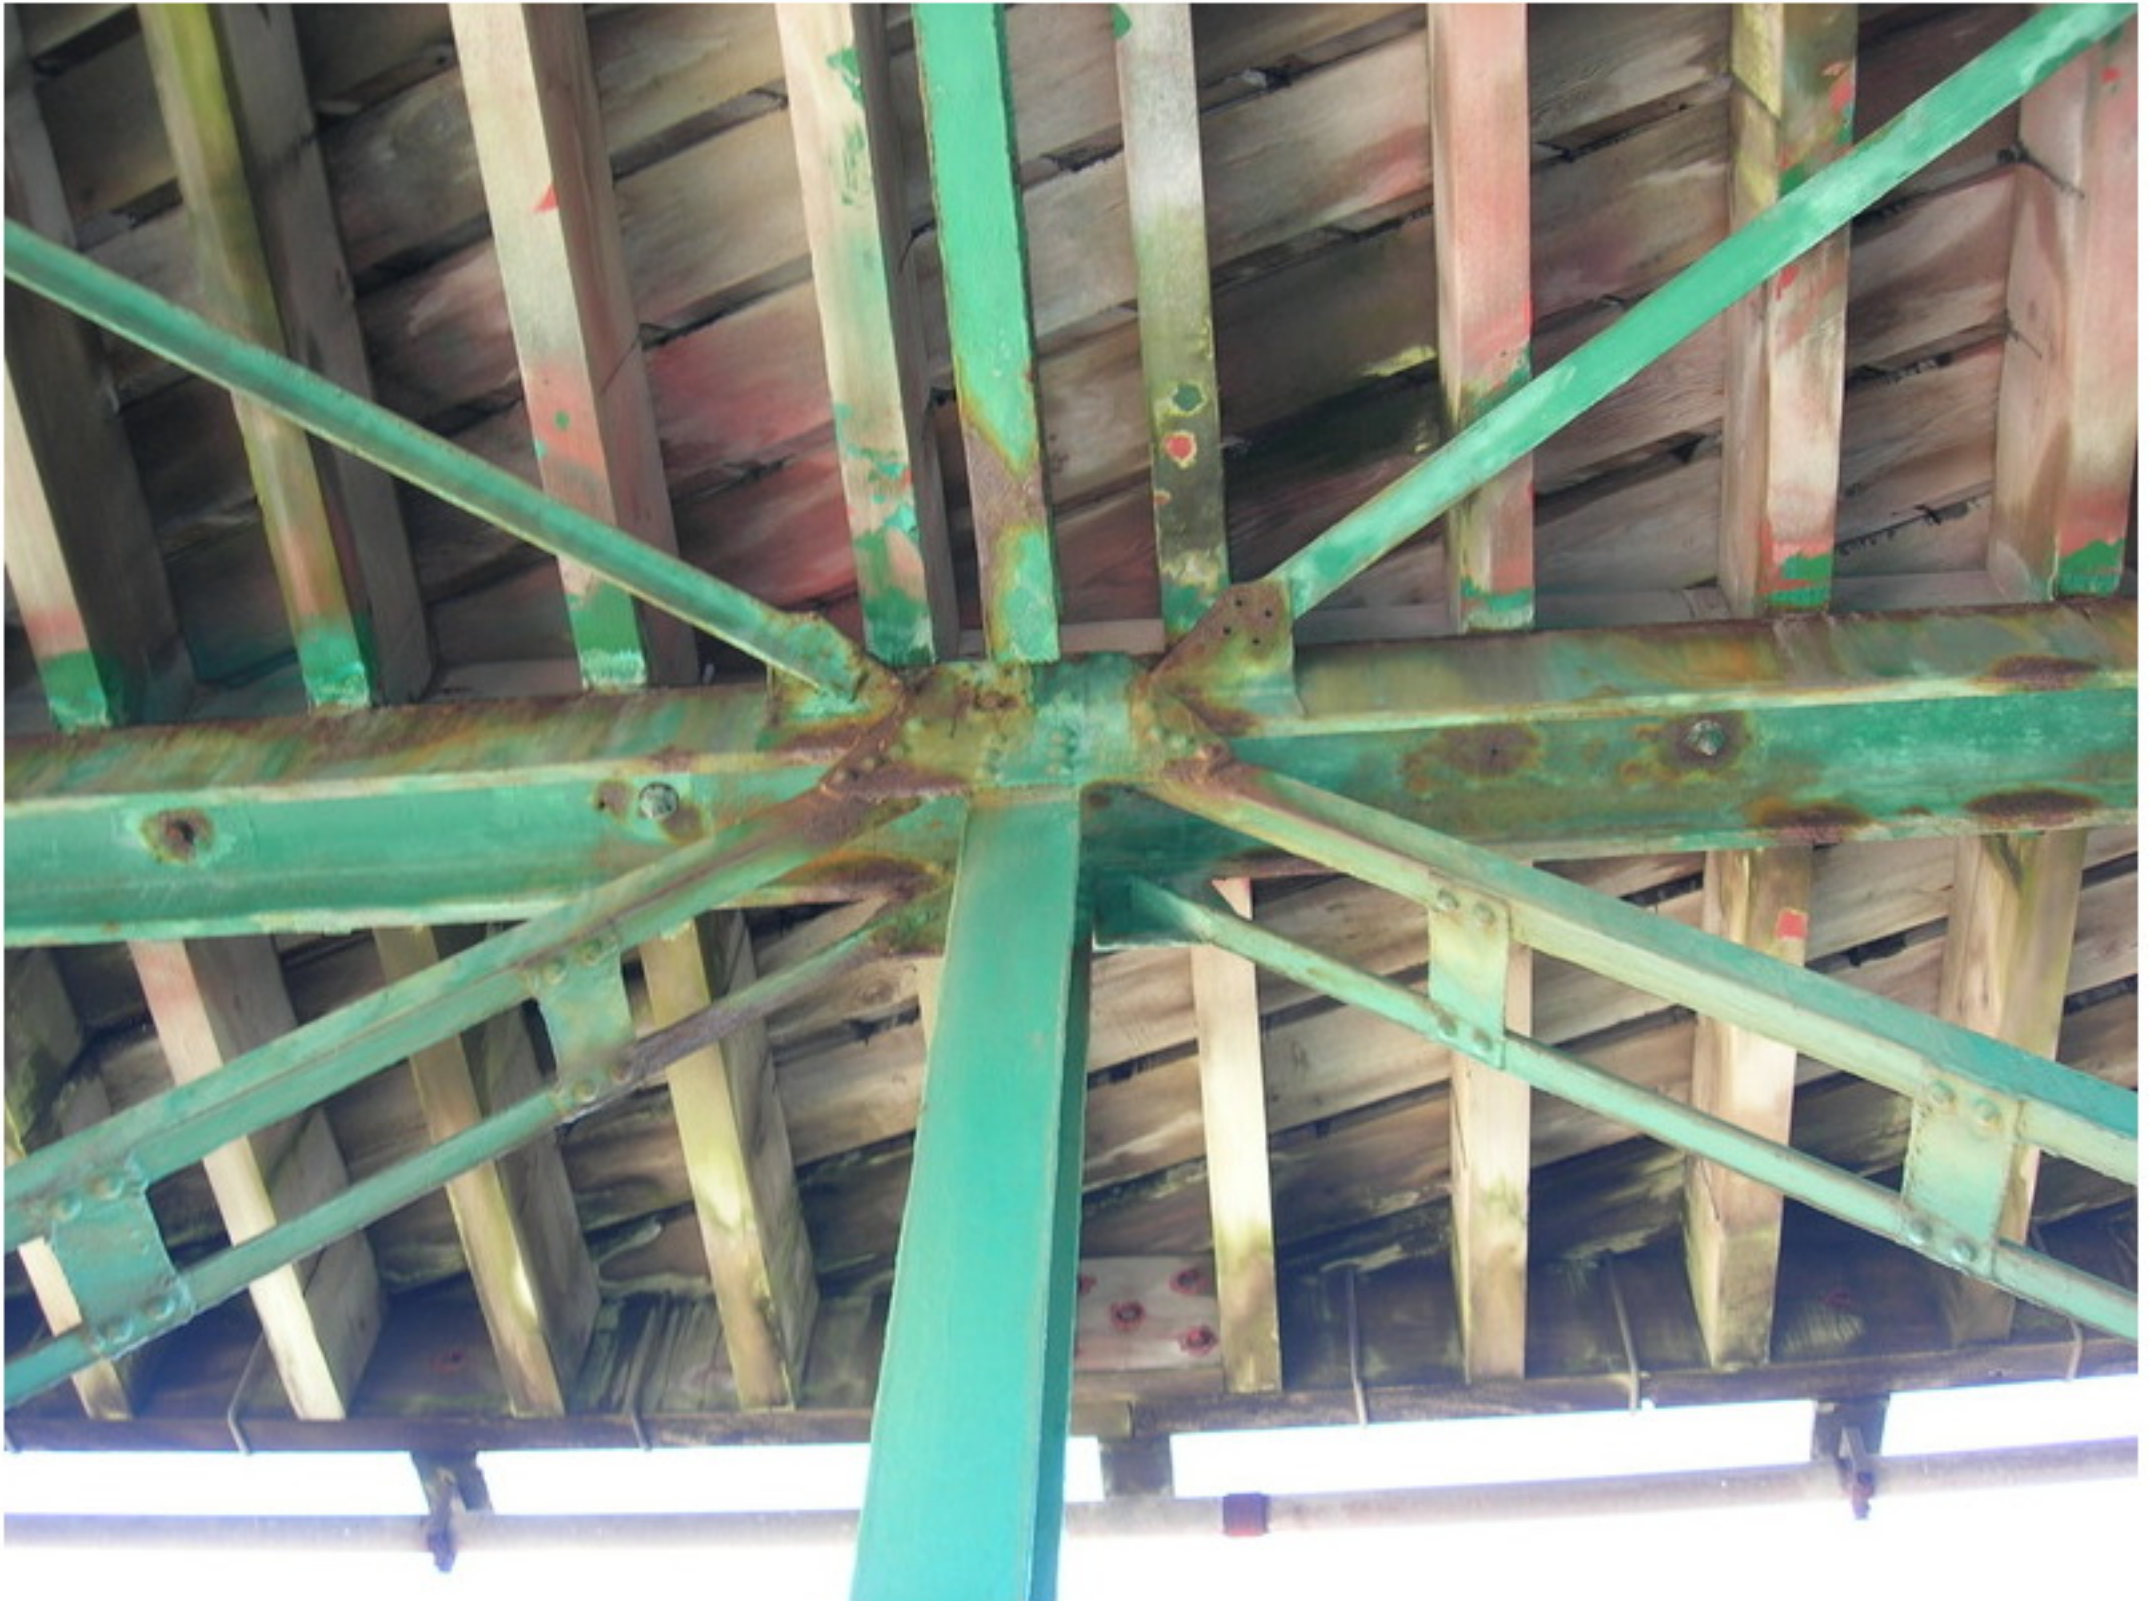
Photo No. 16
Looking up at corrosion on the steel members of the upper chord of the main span truss
